## INFLUENCE OF POLARIZATION RATE ON LOCALIZED CORROSION OF STAINLESS STEEL USED IN GARBAGE COLLECTOR TRUCKS

The corrosion rate of SAE 5115 steel located inside a garbage compactor trucks and the corrosion products originated by an aqueous solution called leachates containing dissolved salts and heavy metals at room temperature and for exposure of five years were studied. We conducted accelerated trials using a contaminant such as the above-mentioned slurry. Microscopy techniques and polarization curves were used. Using microscopic techniques, the degree of advance was determined and correlated with the corrosion rate, determining the degree of deterioration due to pitting type corrosion, establishing a direct relationship between the rate of deterioration and the time of onset of pitting corrosion in contact with leachates.

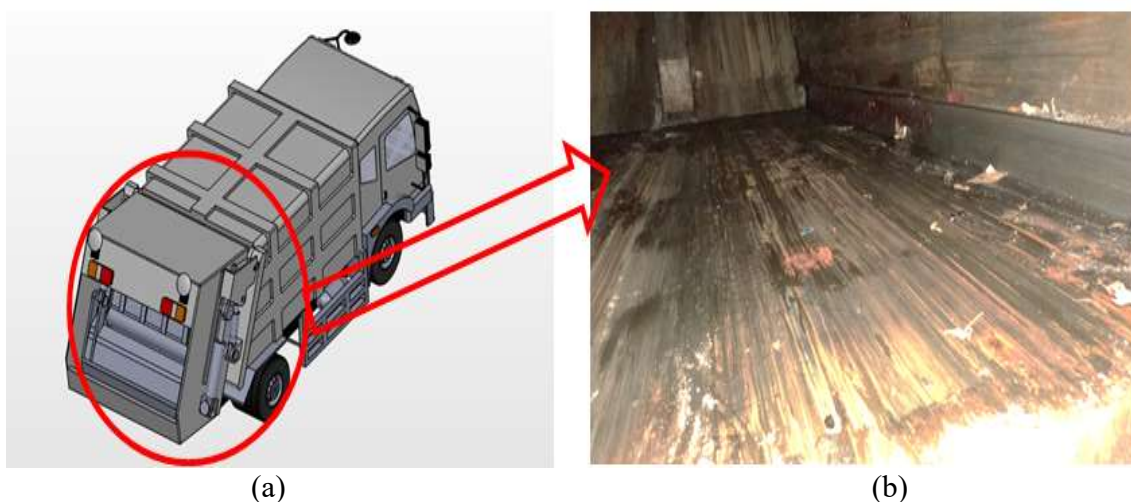
Figure-1(a) shows a scheme of a garbage truck. Figure-1(b) shows the damage caused by leachate in the compacting box of the waste collection vehicle. The deterioration of the steel structure is due to the phenomenon of pitting corrosion.

Fig.-1: Basic Aspects of a Garbage Truck (a) Diagram of the Garbage Truck and (b) Detail of the Corrosion Damage in the Garbage Compactor.

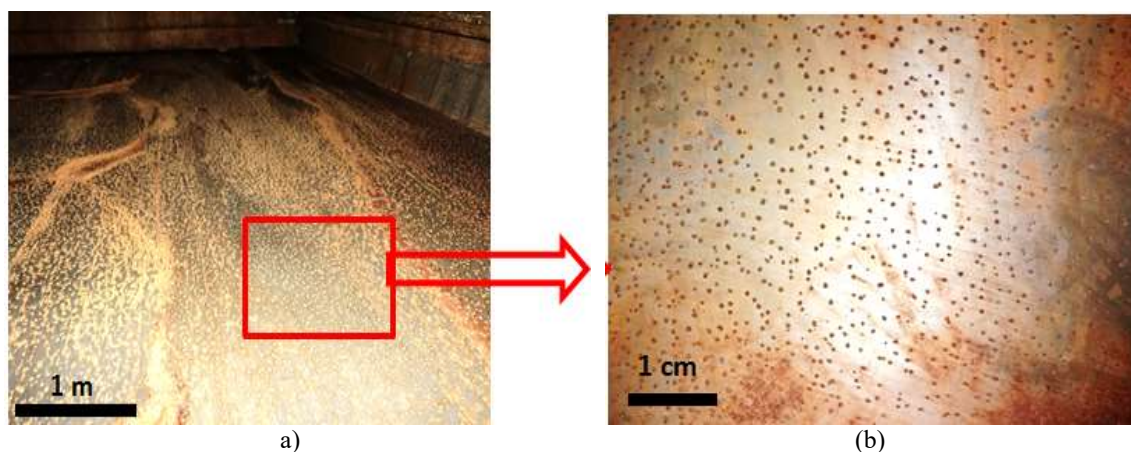
A more rigorous analysis of the metal surface is shown in Fig.-2. Damage to the metal surface caused by contact with leachate is evident (Fig.-2a). Figure-2b shows in detail a type of localized attack manifested as perforations in the metal plate.

Inspection of the plate after wear was detected, (Fig.-2) revealed corrosion on the surface exposed to the leachate. The presence of brown corrosion products deposited on the external and intermediate surface of the holes is observed. Afterward, several cuts are made to evaluate them with the technique of potentiodynamic polarization curves to determine the rate of deterioration.

Fig.-2: Corrosion Damage to the Compactor Box Section of a Garbage Truck. (a) General View and (b) Detailed View.

The previous analysis allows one to establish that the type of wear in the steel sheet is generated by accelerated corrosion phenomena. The existence of two classes of zones is evidenced (Fig.-2), one in which there is no accumulation of particles and the other zone corresponds to the deteriorated region related to excessive material detachment. The deterioration speed for the specimen with a protective oxide layer is 0.028 mpy (milli-inch per year). The results establish a similarity for steel specimens that present deterioration caused by corrosive processes and samples subjected to surface polishing; the values established in these conditions are 0.392 mpy and 0.283 mpy, respectively.

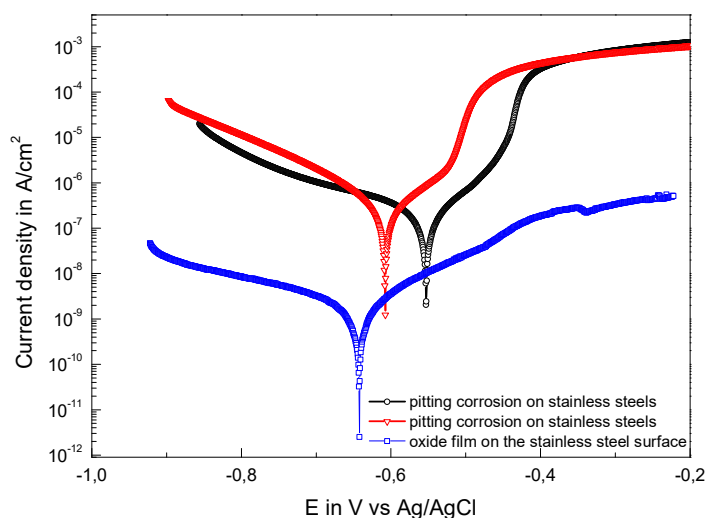
Figure-3 shows three potentiodynamic polarization curves of SAE5115 steel samples when immersed in the solution simulating the leachate. The passivity filler at current density,  $\sim 10^{-7} \text{ A cm}^{-2}$ , is presented for the sample that has a protective oxide film. However, this film is unstable due to increased corrosion current density when the anodic potential varies.<sup>21</sup>

The steels were evaluated at different speeds and taken as representative samples one from the floor of the truck structure (red curve, Fig.-3) and the other from the wall (black curve, Fig.-3). The results indicate the same behavior established by low stability. This result explains why the anodic region shows a low passivity potential range, followed by an increase in the corrosion current indicating the existence of pitting corrosion phenomena caused by the presence of chloride ions, the pH value and the reduction-oxidation potentials. These factors can cause the rupture of the passive film and subsequent attack on the substrate.

Leachates generate a reducing capacity due to their high pollutant factor, due to the content of organic matter and heavy metals of which they are composed. In the polarization curves, it is observed that at 100 mV, in the anodic region, there is an increase in the current density when the potential reaches the critical value ( $E_{\text{pit}}$ ), the current density<sup>22</sup> is  $\sim 10^{-3} \text{ A cm}^{-2}$ . A proportional behavior between the increase in corrosion velocity and the pitting corrosion current density values can be evidenced. The results allow for a decrease in four orders of magnitude of the system without a protective layer concerning the system protected by the layer, this situation leads to increased corrosion current density.

Fig.-3: Polarization Curves, Where Systems with and without Protection are Evaluated and their response in Pitting Potential ( $E_{pic}$ ) and Pitting Current Density of Steel.

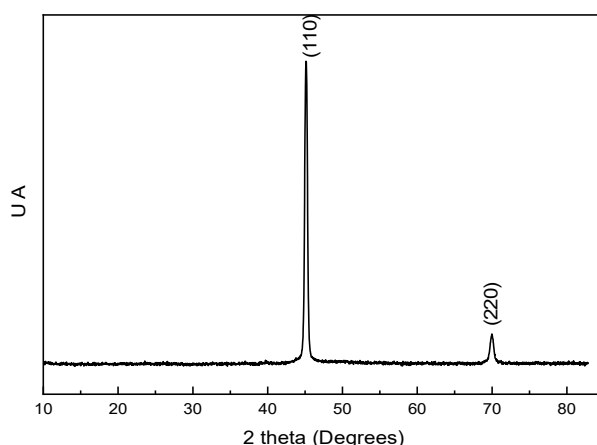
Figure-4 shows the X-ray diffraction pattern for SAE 5115 steel without any leachate attack. An intense peak is observed at  $2\theta = 45^\circ$  corresponding to the diffractions in the planes (110) indicating a high degree of crystallinity of the substrate in this orientation. Also, other peak with lower intensity is evidenced at  $2\theta = 70^\circ$  and is associated with diffraction in the planes (220).

Fig.-4: X-ray Diffraction Spectrum, Corresponding to SAE5115 Steel Substrate.

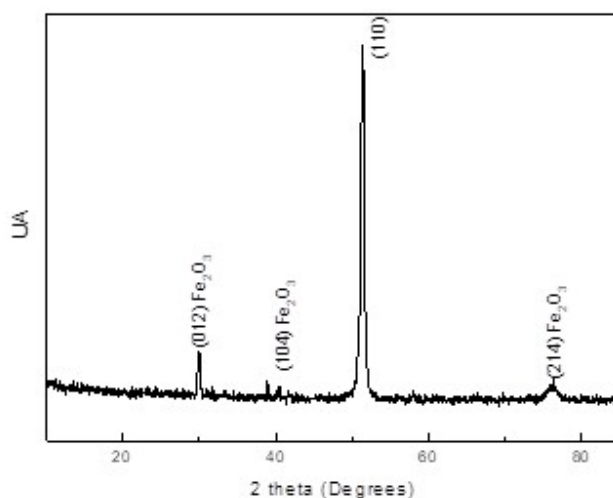
Figure-5 shows the X-ray diffraction pattern for SAE 5115 steel after exposure to leachate degradation. Three oxidizing elements related to peaks are obtained at  $2\theta = 30^\circ$ ,  $40.47^\circ$  and  $76.25^\circ$ , associated to the

crystallographic planes (012), (104) and (214), respectively. The compositional analysis from the previously related peaks allows the semi-quantitative determination of the concentration of oxides present. The results of the topographic evaluation by SEM are observed in the micrographs in Fig.-6. There are areas affected by corrosive processes as a result of corrosion tests. This type of corrosion occurs when there are anodic and cathodic regions with a difference in electrochemical potential, originated by ion exchange by immersion in the electrolytic medium (leachate)<sup>23</sup>. For the characterization of the corrosion products, the area marked with red is chosen in Fig.-6. The result of the analysis is the presence of iron oxides and chlorine (hypochlorous anhydride). The pitting corrosion is attributed to the presence of chloride ions. This type of ions promotes the breakage of the passivating layer in localized areas of the metallic surface, which is consistent with the formation of small holes evidenced in Fig.-2a.

Fig.-5: X-ray Diffraction Spectrum, Corresponding to Steel after Exposure to Degradation in a Leachate Medium.

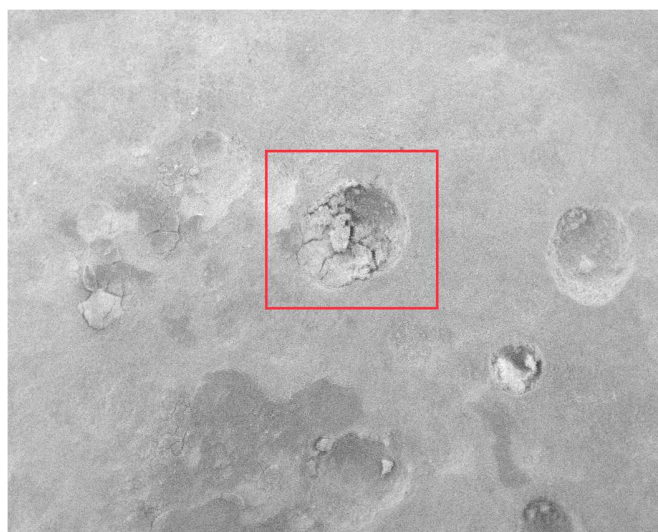
Fig.-6: Micrograph with Composition Analysis Corresponding to the Area with Oxide Layer.

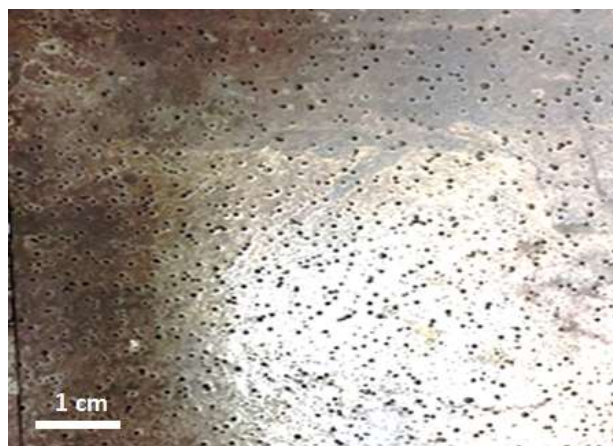
Figure-7 shows the results on the metal surface due to prolonged exposure to leachate. A high degree of wear is determined related to the perforations generated by the anodic zones. As previously mentioned,

visual inspection allows determining a localized or pitting corrosion process, after exposing the metal with the leachate and developing accelerated corrosion tests. From the results, it can be inferred that the presence of oxidizing agents in an environment composed of chlorides is generally very harmful and will favor pitting corrosion processes<sup>19</sup>. The oxidizing agent, chloride ion, increases the probability of pitting corrosion by providing additional cathodic reagents and increasing the overall local potential. It is determined that metal, SAE 5115 steel, in contact with leachates does not generate passivating layers. Pitting corrosion is considered accelerated in nature, that is, when a pitting starts to grow, the local conditions are altered in such a way that the growth of the pitting is promoted.

Fig.-7: Metal Sample after Prolonged Exposure to Leachate Attack.

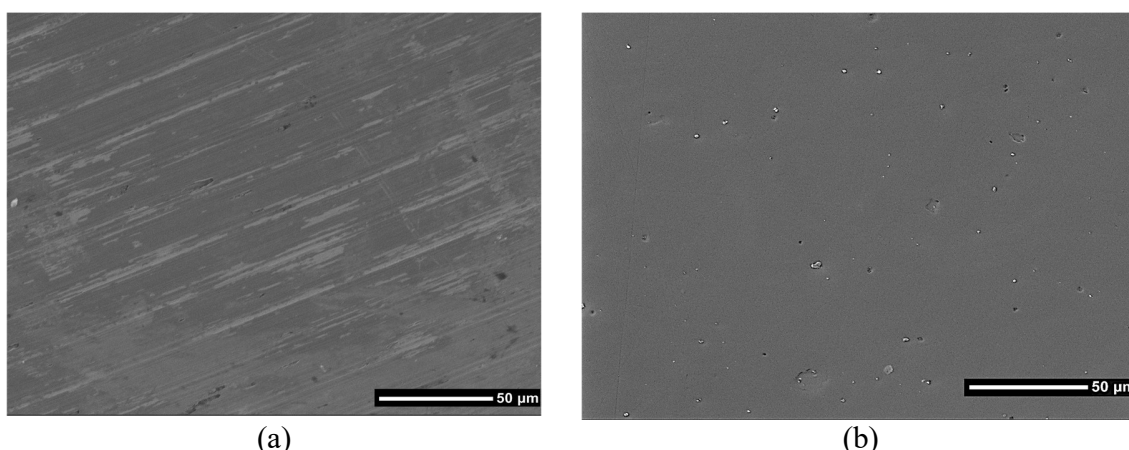
Figure-8(a) shows the posterior region of the analyzed steel specimen. The initial visual inspection makes it possible to establish that there is no localized corrosion or pitting. By exposing the metal with the leachate and performing accelerated corrosion tests in a chloride environment, the presence of very harmful oxidizing agents is observed that favor pitting corrosive processes (Fig.-8b). The micrograph shows areas that do not present corrosion problems. This indicates the absence of agents due to the protective layer of the steel material. However, by making contact and abrasion, a function performed by the garbage compactor carriage, it is not possible that this coating is resistant to localized corrosion. It is also important to point out that the presence of this protective layer in the system can induce passivity, as can be seen in Figure 8b) where the phenomenon of localized corrosion is minimal.

Fig.-8: Micrographies of the Areas that do not present Corrosion Problems.
