STUDY ON GROUND WATER QUALITY IN AND AROUND PERUNGUDI SOLID WASTE DUMPING SITE IN CHENNAI

K. Prasanna and R. Annadurai

Department of Civil Engineering, SRM University, Kattankulathur-603 203

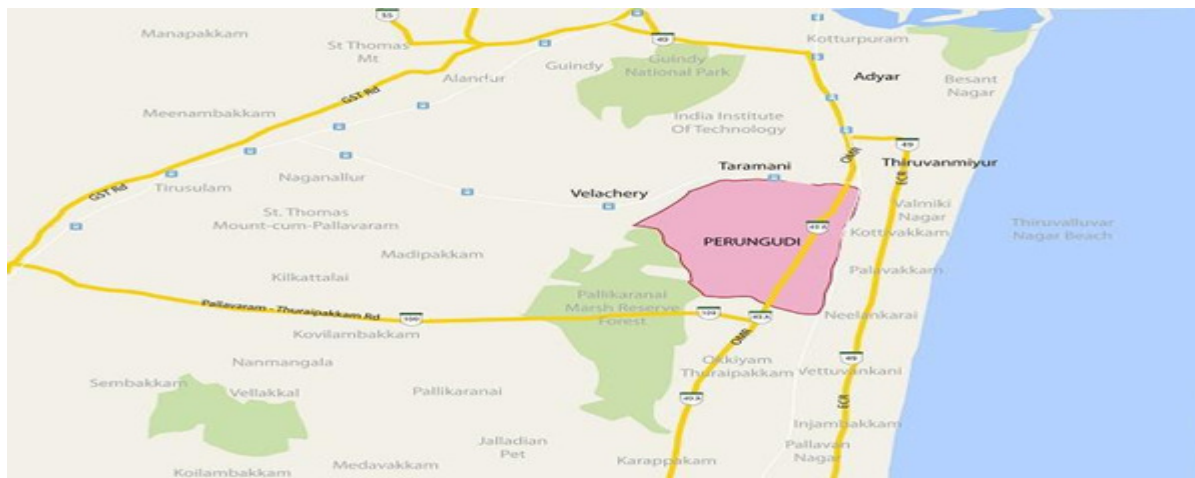
Fig.-2: Map showing Perungudi area

The Figure-1 shows the methodology adopted for this study. Whereas, Figure-2 shows the location of the Perungudi landfill site (Fig.-2), where the study was conducted.

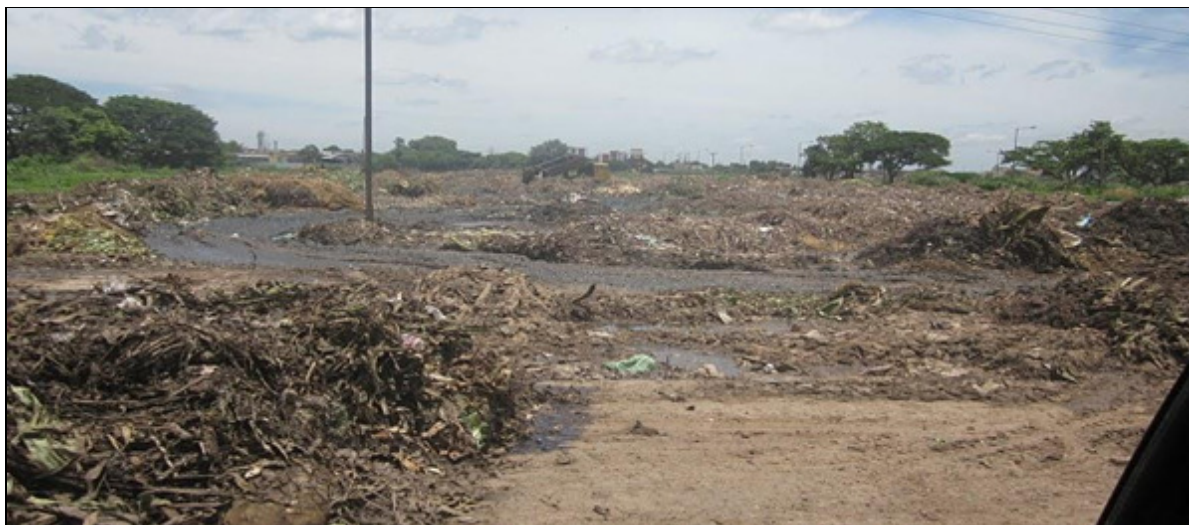
Fig.-3: Perungudi landfill site

For the initial study the leachate sample was collected for the landfill site. The leachate was collected from the water logged areas near the dumping ground. The moisture content coming out of the waste gets accumulated near a low land area. Sampling site shown in Figure-3 and Figure-4
